TOTTEN.

No. 6.

8. "In order to the execution of these objects, "there has been prepared in this office, and approved "by the Secretary of War, a drawing of a masonry "target 67′ 8″ long, 5 feet thick, and 10 feet high "above the foundations; containing six gun embra- "sures of dimensions adapted to casemated batteries. General dimensions of target.

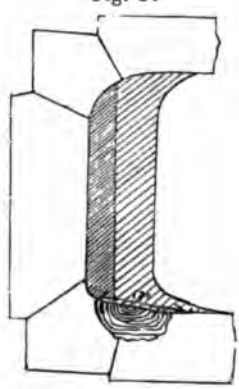
120	42	$\frac{1}{8}$	Can'r.	48	$\frac{1}{2}$	200	No. 9	Thirteen shots struck the target. One of them struck the sill of No. 9, a Fig. F.

few inches below the sole, knocking out a piece of concrete 13″ by 7″ by 8″. Nothing went through.

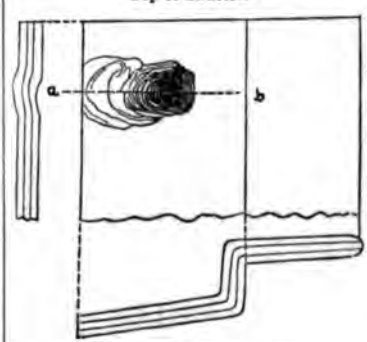
Fig. M.

Order of firing.	Calibre.	Charge of powder.	Projectile.	Weight of projectile.	Elevation.	Distance.	Object.	REMARKS—July 24, 1855.
No.	inch.	lbs.	kind	lbs.	degrees	yds.	at	
178	8	$6\frac{1}{2}$	Grape	$51\frac{1}{4}$	$\frac{1}{2}$	200	No. 7	One shot struck the target in the granite. Penetration about $\frac{1}{2}$″.
179	8	$6\frac{1}{2}$	Grape	$51\frac{1}{4}$	$\frac{1}{2}$	200	No. 7	One shot struck the right outer edge of No. 8 about 4″ from the edge; cut through the brick, and was stopped by the shoulder of offset which was covered with a plate of $\frac{1}{2}$ inch boiler iron, doing no damage to the plate which it impressed about $\frac{1}{4}$ of an inch. One shot struck the granite.
180	8	$6\frac{1}{2}$	Grape	$51\frac{1}{4}$	$\frac{1}{2}$	200	No. 7	One shot struck the right shutter of No. 7, 4″ from the top and $5\frac{1}{2}$ inches from the edge, indentation about 4″ dia. and $\frac{5}{8}$″ deep. The diameter of the part touched by ball about 2″. The lower bolt head of the latch was considerably broken off, and the bolt somewhat started in. The shutter was slightly bent, behind the part where the shot struck, but not damaged. The other shutter, for want of a latch, was thrown partly open. The shot was broken. One piece, about one-third of the shot, was found on the inside, but it left no mark on the screen.

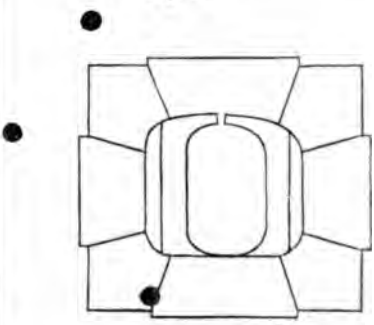
Order of firing.	Calibre.	Charge of powder.	Projectile.	Weight of projectile.	Elevation.	Distance.	Object.	REMARKS—July 24, 25, 26, 1855.
No.	lbs.		kind	lbs.	degrees	yds.	at	
181	24	¼	Ball	24	½	200	Mark on concrete between No. 9 and end of target	Shot was lost.
182	24	¼	Ball	24	½	200	Do.	Shot struck about 1 foot above the left end of the lintel of No. 9. Penetration 1′ 10″. Exterior diameter of crater about 3′ 6″, extending to the top of the wall, where it was 4′ 6″, and cracked the wall entirely through, and extending to the end of the wall on the left. Ball did not break. For point struck see Fig. N.
183	24	¼	Ball	24	½	200	Do.	Shot struck to the left of the lintel of No. 9, about 1′ 9½″. Penetration 1′ 3½″. Exterior diameter of crater 2′ 6″. Cracked the concrete horizontally to the end of the wall. For point struck see Fig. N.
184	24	¼	Ball	24	½	200	Do.	Shot struck on the sill about 10″ from the edge, on a line with the edge of the left side produced—penetration 10″, the shot having struck the outer

Order of firing.	Calibre.	Charge of powder.	Projectile.	Weight of projectile.	Elevation.	Distance.	Object.	REMARKS—July 24, 25, 26, 1855.
No.	lbs.		kind	lbs.	degrees	yds.	at	
								sill stone—cracking the sill through to the inner face of the wall, through both of the inner sill stones, without displacing either, or the iron offset—the crack being a slight one. The ball was broken. The action of the ball seems to have been communicated directly to the left throat plate; thence to the inner sill stones, cracking the first one in a slight crack directly to the rear, and loosening the joint of the sill stone with the cheek of the embrasure. The rear sill stones were cracked directly to the rear, a continuation of the crack through the first; this stone was loosened in its bed, and at each end cracked from the cheeks. The crack at the left end continued down some 18″ between the brickwork and the end of the stone under the sill. At the other end the brickwork of the cheek was slightly cracked for about 12″, in a line inclining at an angle of 45° to the back of the wall. A slight disturbance of the mortar was visible in the joint between the brickwork, and the stone under the back sill, as at the other end. At the top, the shock on the cheek plate scaled off a small portion of the brickwork from the soffit of the arch. The embrasure as serviceable as ever apparently. For point struck see Fig. N.

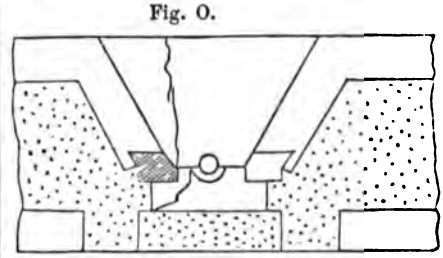
Fig. O.

185	24	¼	Ball	24	½	95	No. 9	Shot struck directly under the axis of the embrasure opposite the tongue hole, passed through, into, and through the tongue hole and under

Order of firing.	Calibre.	Charge of powder.	Projectile.	Weight of projectile.	Elevation.	Distance.	Object.	REMARKS—July 24, 25, 26, 1855.
No.	lbs.		kind	lbs.	degrees	yds.	at	
								the screen. Carried away all the concrete in front of the outer sill, as low down as the point where the ball struck. Cracked the outer sill stone up and down directly through the centre, and horizontally towards the left, about 4″ below the top of the sill, as far as the crack caused by the previous shot. No additional derangement of the sill stone in the rear, or of the stones around the tongue hole. The ball in passing through the tongue hole, did not carry away any bricks, but broke off the corners of those on the inner edge. Embrasure still serviceable; although, had the casemate carriage been mounted, the pintle would probably have been broken.
186	24	¼	Ball	24	½	95	Left throat plate No. 9	Through without touching.

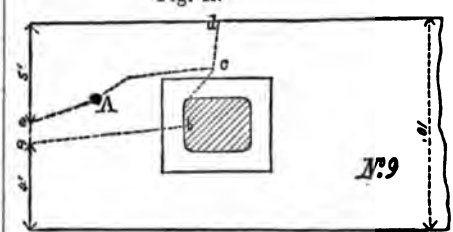
Order of firing.	Calibre.	Charge of powder.	Projectile.	Weight of projectile.	Elevation.	Distance.	Object.	REMARKS—July 26, 27, 1855.
No.	inch.	lbs.	kind	lbs.	degrees	yds.	at	
193	8	10¼	Ball	68	⌀	200	Between No. 9 and end of target	*A*, point struck. Penetration 2′ 2½″. All between the lines *a b* and *e A c* partially ruined. All outside the line *e A c d* ruined. Considerable portions knocked off, wall being much shaken by previous shots. The ball fell back whole. Fig. R.

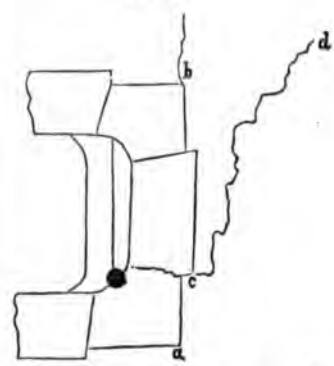
194	8	10¼	Ball	68	⌀	200	Right cheek, No. 9	Ball struck at the foot of the boiler plate, at the junction between it and the sill, penetration 1′ 9″. Fig. R′.

Ball stopped and broke to pieces. Line *a b* is right edge of the embrasure jamb. Crack along *a b* and along

Order of firing.	Calibre.	Charge of powder.	Projectile.	Weight of projectile.	Elevation.	Distance.	Object.	REMARKS—July 26 and 27, 1855.
No.	inch.	lbs.	kind	lbs.	degrees	yds.	at	
								c d to the top of the target. The shock cracked the rear sills entirely through, in direction of the shot. The right cheek was cracked obliquely from the bottom of the throat piece (right) to the top of the cheek to the rear. A large crack was made through the corner of the arch. Several bricks were torn out of the rear part of the right cheek by the shock from the sill stone. Several scaling cracks were made in the cheek behind the throat plate.
195	8	10¼	Ball	68	⅜	200	Right cheek, No. 9	Ball struck the right jamb of No. 9, in the concrete near its junction with the brickwork, and about 10″ below the plane of the lower surface of the lintel. The ball passed through the wall, leaving evidences of having been slightly deflected to the left, as it approached the inner cheek, forced the throat plate completely from its position, throwing the upper end against the opposite side of the embrasure, and leaving it in the opening inclined at an angle of about 45°. The plate of boiler iron of the outer offset was thrown from its position to the front, out of the embrasure. The horizontal dimension of the embrasure at the throat was enlarged by this shot, and by those on the opposite cheek, to 4′ 10″. The brickwork to the right of the point where the ball struck was considerably carried away within a radius of about 1′ 9″ to 1′ 10″, and several cracks in the beds of the brickwork, extended 5′ to 5½′ to the right. Three large cracks also extended to the top of the wall obliquely to the right and left. The main effect of this discharge was caused by the ball passing entirely behind the throat plate, between it and the masonry, forcing the plate laterally from its position, as no support whatever was furnished by the opposite throat, it having been carried away by previous discharges. The plate was not touched by the ball or injured by the effects. All the brickwork of the inner cheek, except a part of the three lower cor-

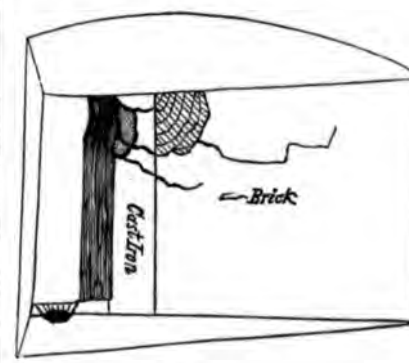
Order of firing.	Calibre.	Charge of powder.	Projectile.	Weight of projectile.	Elevation.	Distance.	Object.	REMARKS—July 26 and 27, 1855.
No.	inch.	lbs.	kind	lbs.	degrees	yds.	at	
								ners, was carried away, and the inner arch was cracked through and through, from the spring to the crown, and also along the joints of the lower string course. A part of the screen, about 7 feet square was carried away.
196	8	10¼	Ball	68	2°	200	Left cheek, No. 8	The shot struck the left throat plate about 4½″ below the top, lapping on the throat plate about half the diameter of the ball, was deflected to the right, breaking out small segments from four of the plates, and bending the inner plate 1¾ inch. Penetration 4⅛ inches. It also broke off a wedge-shaped piece of cast iron 1′ high, 3″ thick, and 2¾″ to 4¼″ broad, measured towards the inner face. The cast iron was also cracked horizontally about 4″ below the roof of the em- Fig. S.

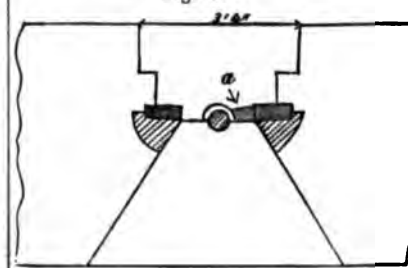
Order of firing.	Calibre.	Charge of powder.	Projectile.	Weight of projectile.	Elevation.	Distance.	Object.	REMARKS—July 26 and 27, 1855.
No.	inch.	lbs.	kind	lbs.	degrees	yds.	at	
								brasure. Two other small cracks were also made, but probably not through the mass. Behind the cast iron on the inner cheek a wedge-shaped mass of brickwork about 1′ high, 3″ thick, and 9″ broad, measured along the cheek, was broken off, and several minute cracks on the inner face, directly behind the iron work were distinctly visible. A crack was also made on the inner arch, along the ring courses, about 5″ from the inner face, extending from the springing line to within six inches of crown. No disturbance was visible on the inner face of the wall, nor bottom of inner cheeks. A small part of the arch 2″ thick, where the cast iron enters, was broken off. Also a small piece of the outer granite sill from pintle to throat plate, 6″ wide and 7″ deep; see *a*, Fig. T. Embrasure still serviceable.

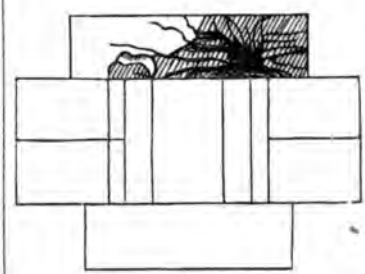
203	8	10¼	Ball	68	¼	200	Centre No. 7	The shot struck the lintel about 4″ above the lower edge, and 5″ or 6″ to the left of the right outer edge; shattered the lintel in all directions, and disturbed the joints obliquely to the right and left, as far as the top of the wall. The ball was deflected downwards, and stopped, after penetrating as far as the offsets of the shutters, say 10″. It was broken in pieces (partially against the offsets of the shutters), two or three of which passed through the screen. The screen was not otherwise injured. The fracture in the lower portion of the lintel extended in as far as the throat, and towards the left in two large cracks about 1′ 10″. To the right, the lintel was fractured and broken off to the depth of 4¼″, as far as the end and top, *i. e.* 1′ 3″. The inner lintel was slightly disturbed in its bed, and the end behind the point struck, started in. The disturbance

Order of firing.	Calibre.	Charge of powder.	Projectile.	Weight of projectile.	Elevation.	Distance.	Object.	REMARKS—July 26 and 27, 1855.
No.	inch.	lbs.	kind	lbs.	degrees	yds.	at	
								was barely perceptible; the iron was not moved; neither of the sill stones were at all disturbed. Slight cracks on the inner face extended to the top of the wall. The embrasure as serviceable as ever, and its general strength not at all impaired. Fig. U.

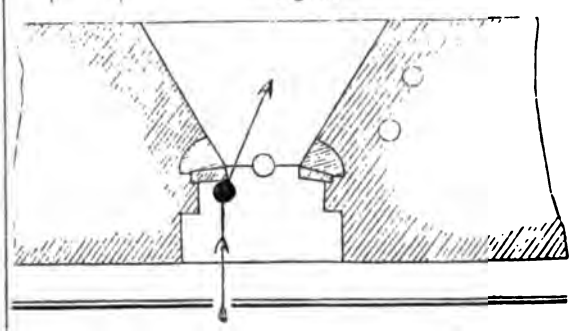
Fig. V.

NOTE.—At this stage of the experiments the disabled shutters were removed.
207	8	10¼	Ball	68	¼	200	Left cheek, No. 7	The ball struck the left throat plate 11½″ below the roof, overlapping the inner edge of the plate somewhat more than half the diameter of the ball; cut a segment from the outer plate of the throat piece 9″ high by 5″ broad, and small pieces from the two adjacent plates. The ball penetrated and bent the plate 4½″ before

Order of firing.	Calibre.	Charge of powder.	Projectile.	Weight of projectile.	Elevation.	Distance.	Object.	REMARKS—July 26 and 27, 1855.
No.	inch.	lbs.	kind	lbs.	degrees	yds.	at	
								it glanced off. The plate was bent on the inside about $2\frac{1}{2}''$, and thrust towards the axis of the embrasure $\frac{3}{4}''$ at the bottom, and $\frac{1}{2}''$ at the top. Behind the wrought iron, a wedge-shaped mass of cast iron 2″ high by 10″ broad and $5\frac{1}{2}''$ at its greatest depth, was broken off and thrown to the right and rear, in two pieces, one 10′ and the other 25′ distant. The fracture in the cast iron was continued into the cheek stones, breaking from them (about equally from each) a wedge-shaped mass 2′ 6″ high, 9″ wide, and $2\frac{1}{2}''$ average thickness. The top of the throat plate struck, was thrust in about $\frac{1}{2}''$. Very little additional disturbance towards the rear at the bottom. Both the inner cheek stones on the side struck were disturbed in all their joints and thrust to the rear about $\frac{1}{4}''$ to $\frac{1}{2}''$. No additional disturbance in the inner sill and lintel. The ball was probably not broken, and went to the right and rear. Embrasure still serviceable.

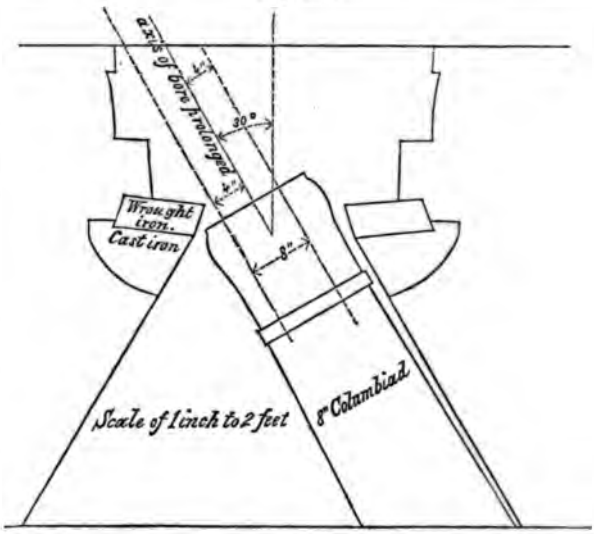
Fig. AA.

Order of firing.	Calibre.	Charge.	Weight of ball.	REMARKS.
No.	lbs.	lbs.	lbs.	
				The Fig. AA shows the position of the muzzle of the 8-inch Columbiad, traversed 30° from the directrix with reference to the throat plates, as they were in the embrasure target.

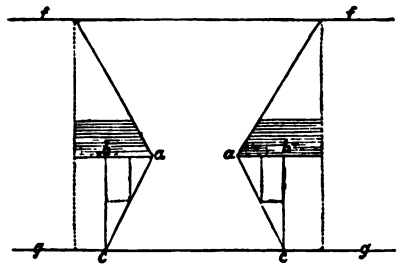
Fig. CC.

198. If the outer portion of the embrasure be traced according to the bent line, *a b c*, instead of the

straight line, *a c*, it is evident that balls that would otherwise be reflected from the surface, *a c*, will be stopped on *a b*.

Compensate for loss of strength by change of form, by introducing a stronger material.

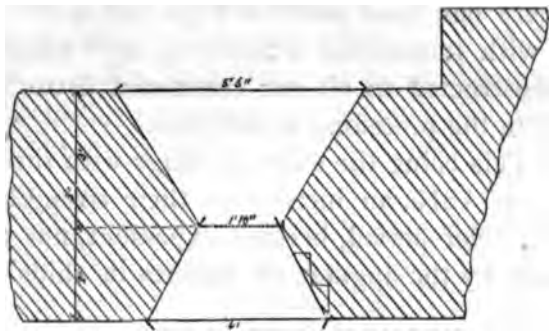
Fig. EE.

Plan of embrasure. 243. The plan of this embrasure shows that the interior opening is 5′ 6″ wide, and that the plane of

the throat is within 2 feet of the outside of the wall, which, just at the embrasure, is 5 feet thick.
